December 8, 2022
Kleinfelder Project No.: 20232926.001A

**SUBJECT: NOVEMBER 2022 SEMI-ANNUAL BARRIER MONITORING REPORT
 MURRAY COSTCO WHOLESALE WAREHOUSE #764
 5201 SOUTH INTERMOUNTAIN DRIVE
 MURRAY, UTAH 84107**

BARRIER INSPECTION SITE MAP

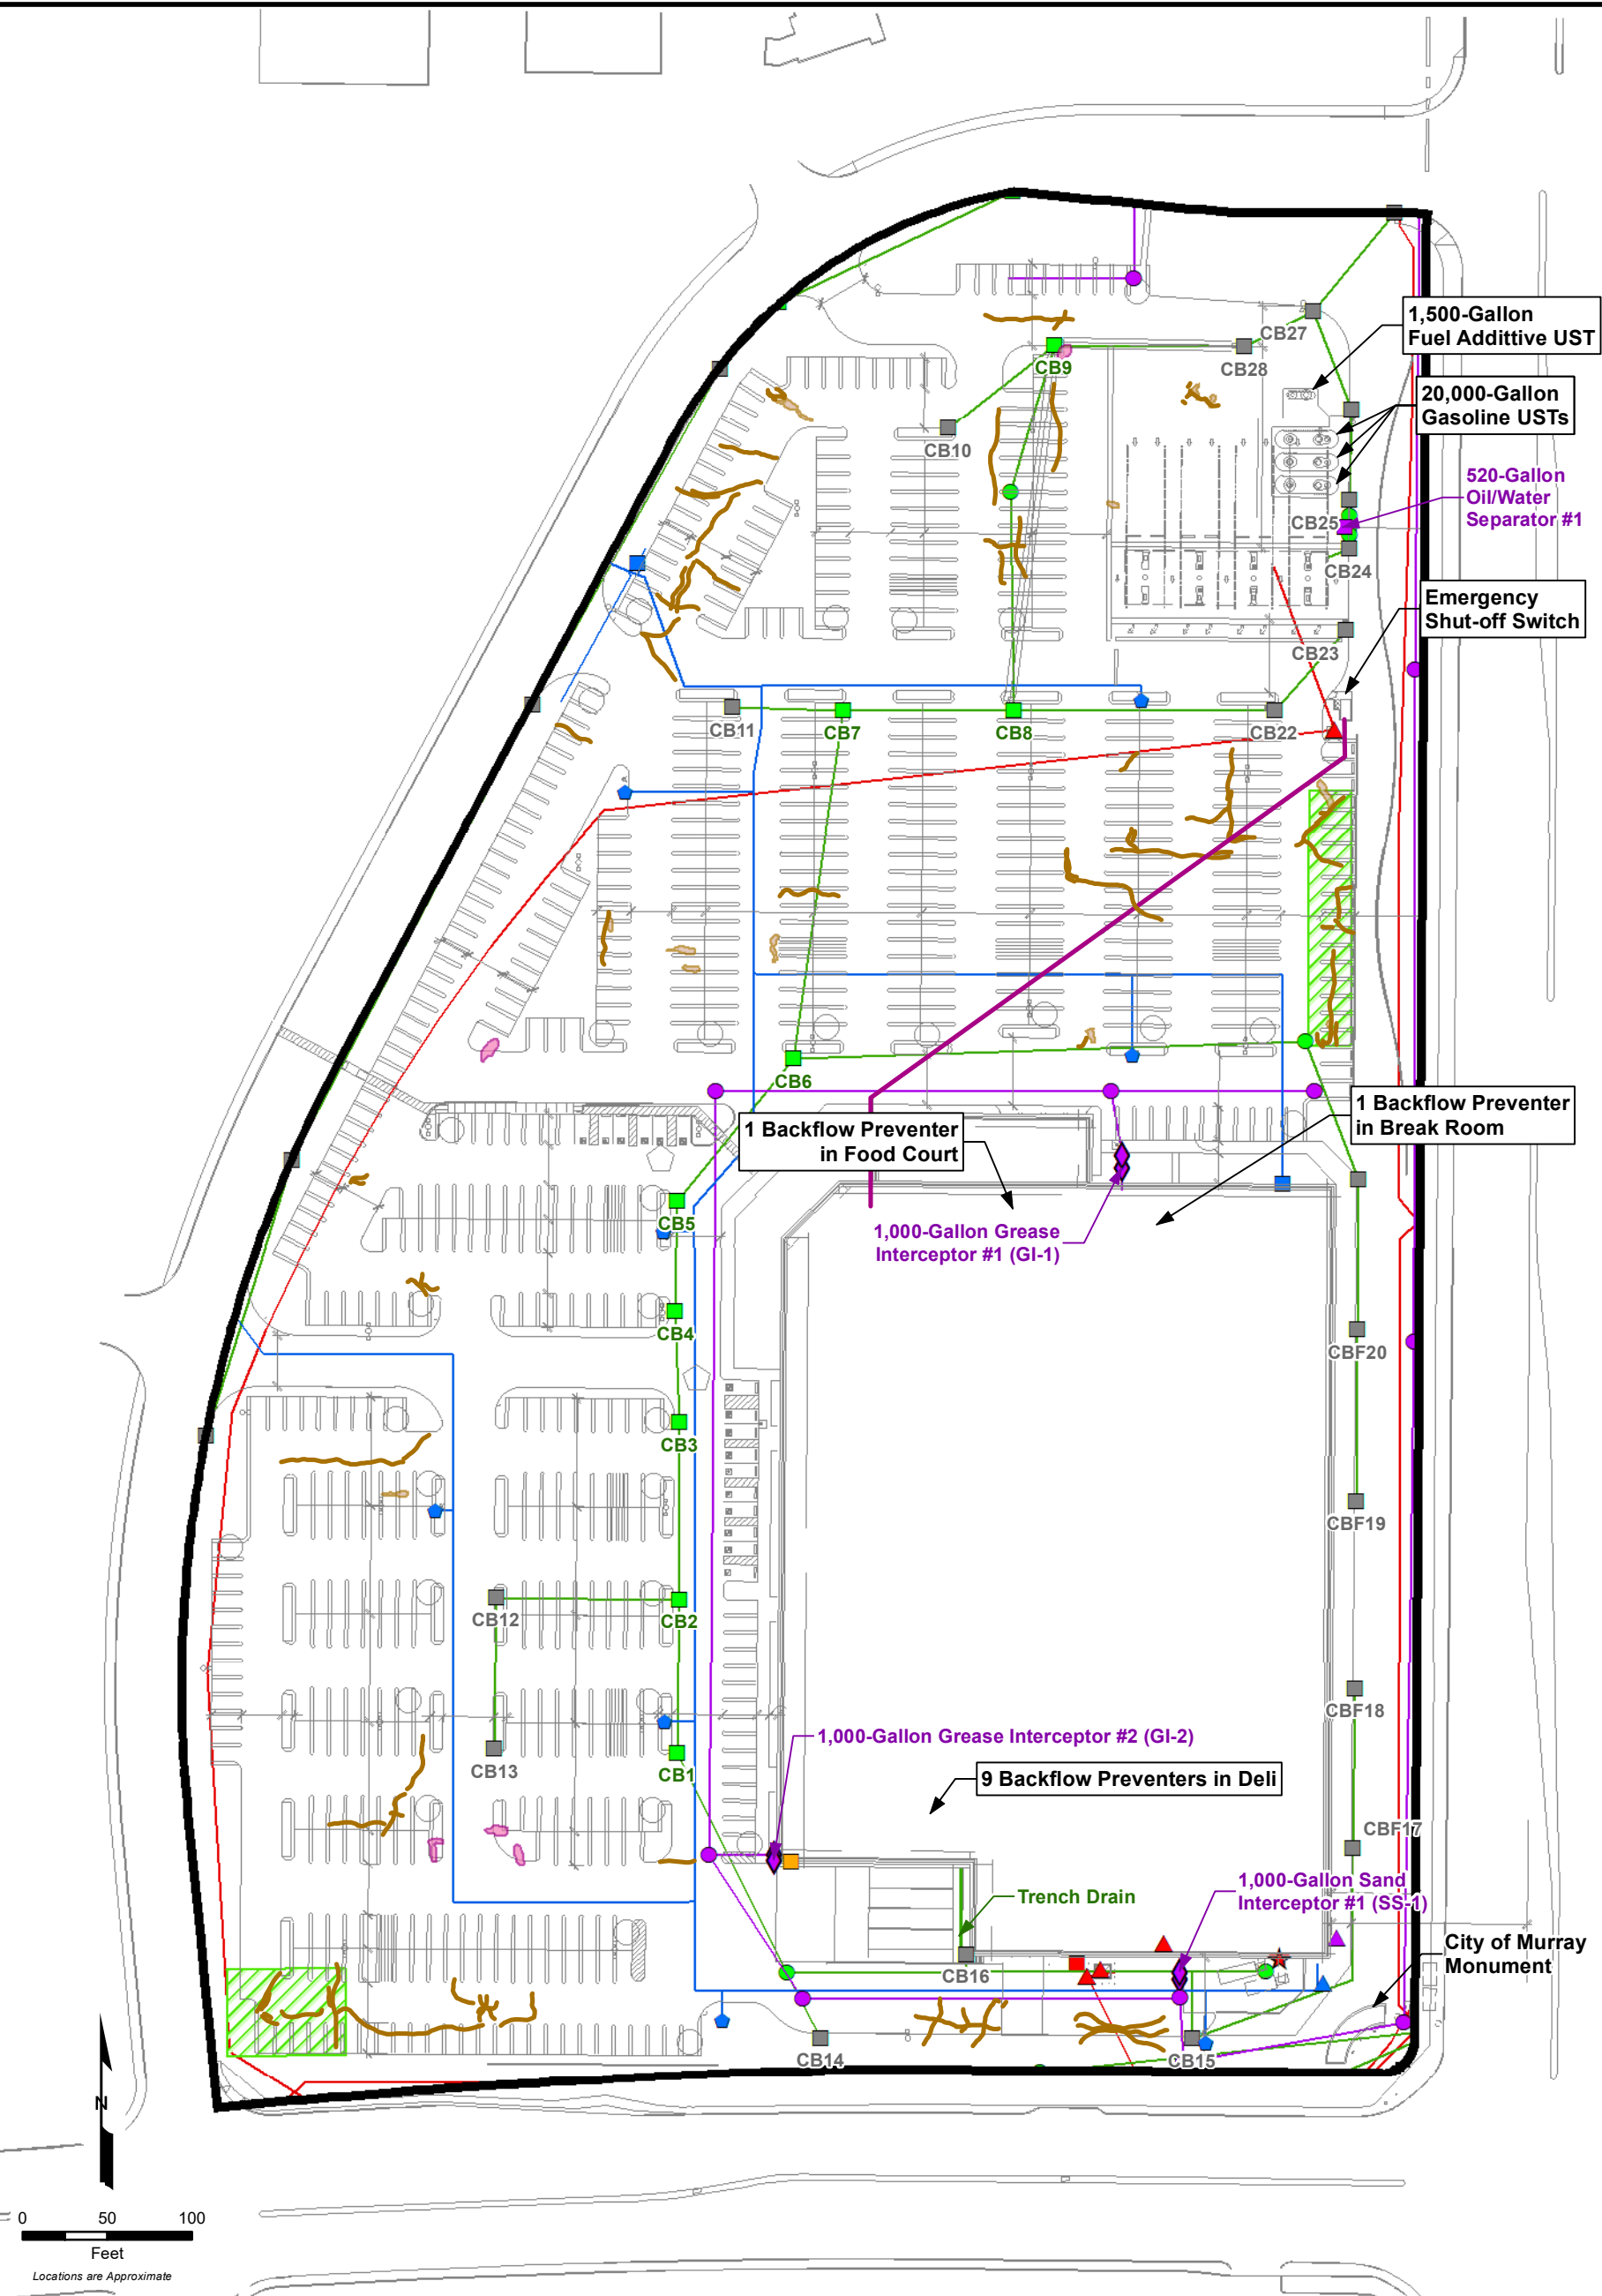
The observed concrete damage on the curbs, as noted on Figure 1, did not appear to extend to, or expose, the underlying soil. The remainder of the concrete barriers, including gutters and loading platforms, were generally in good condition with sealed concrete joints. No cracks, holes, settlement areas, or other physical features that would indicate the integrity of the barrier had been compromised were observed during the barrier inspection. No warehouse building concrete maintenance actions appear to be necessary at this time.

Overall good condition, some damage/chipping on curbs around interior landscaping indicated on map. Not significant enough to allow receptors to be exposed to impacted soil since the chips are above level of landscaping

Observations/Comments: Overall fair condition with minor cracks in the asphalt and tar seals; however, cracks did not breach the barrier or expose underlying soils. Crack dimensions indicated on the map ranged from 1/4 to 1-1/2 inch deep and 1/4 to 1 inch wide, but did not extend the full width of the asphalt.

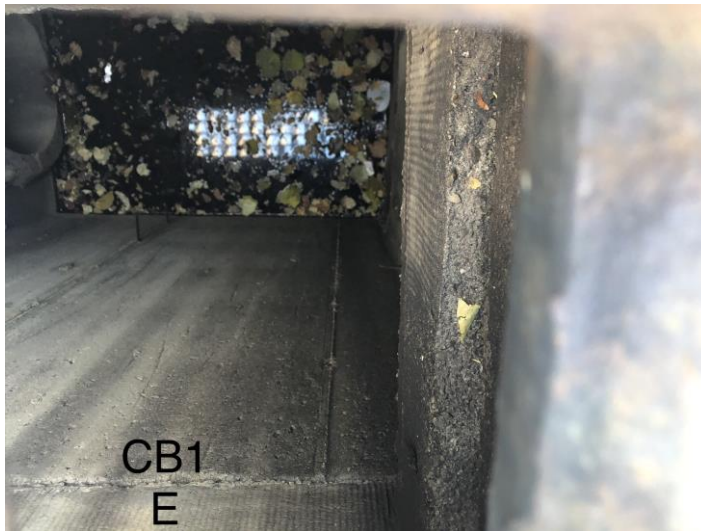
Photograph #1 – View of the north and east wall of CB1.

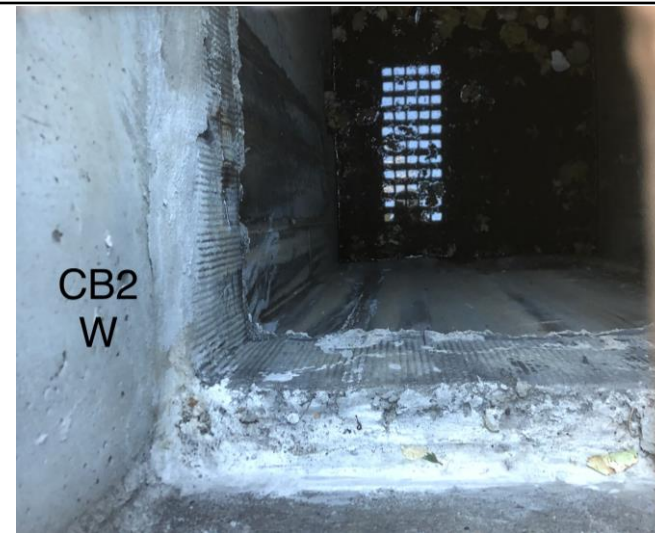
Standing water was observed in eight of the nine inspected catch basins at the approximate level of the inlet and outlet piping. Some dampness and/or water staining was observed on the CB2 and CB3 western sidewalls, originating from joints approximately 3 feet below ground surface (above the depth to groundwater). The dampness/staining was generally observed on the portions of the catch basins adjacent to frequently irrigated areas and not on the walls opposite the irrigated areas. The damp catch basin walls/minor water seepage are not anticipated to impact storm water quality within the drains due to the limited volume of water observed (i.e. no flowing water observed, and the dampness did not extend to the existing standing water levels), and because the seepage occurred above the groundwater table, which has been historically reported at depths approximately 8 to 10 feet below ground surface. Minor water seepage did not appear to originate from the depth of metals-impacted groundwater, which likely is present at the approximate depth extent of the catch basins, or

Yes ☐ No ☒ Dampness observed in CB2 and CB3 at joints above the groundwater table, but does not reach standing water within the catch basins.

Photograph #2 – View of the west and south wall of CB2 with minor dampness and/or staining observed at an upper concrete joint.

Grout was placed in CB2, CB3, CB4, CB5, CB6, CB7, CB8, CB11, CB14, and CB22 in concrete joints and cracks at depths ranging from approximately 3 inches to 6 feet below ground surface in October 2022. The corrective action taken appears effective against the majority of the seepage from these areas that was suspected to be originating from irrigation or other surficial water. Additional repairs will be conducted to address residual, dampness and minor seepage from surficial water infiltration.

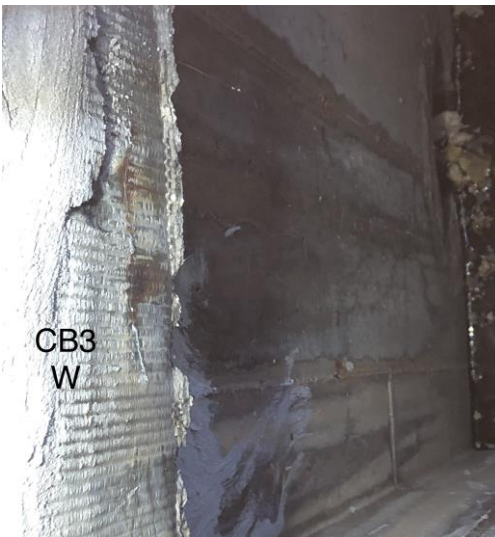
Photograph #3 – View of the west wall of CB3 with and minor dampness and/or staining observed at an upper concrete joint.

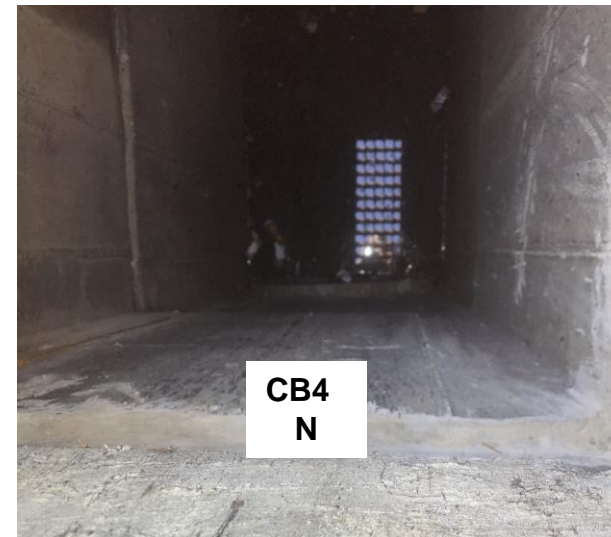
Photograph #4 – View of the north wall of CB4 with grout observed in joint.

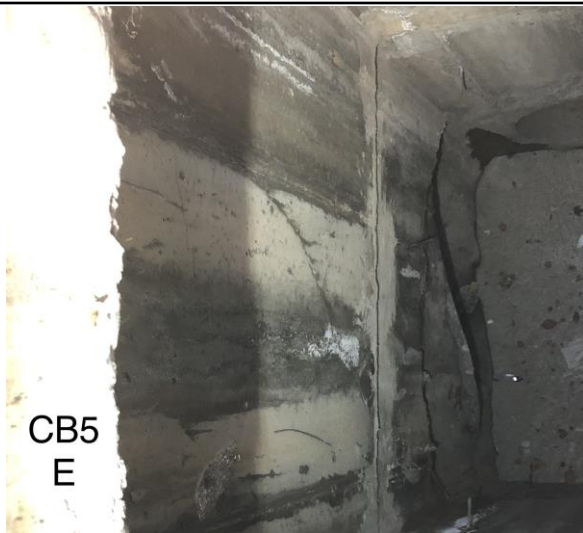
Photograph #5 – View of the east wall of CB5 with grout applied to vertical cracks. Minor staining was observed, but no dampness or standing water was observed.

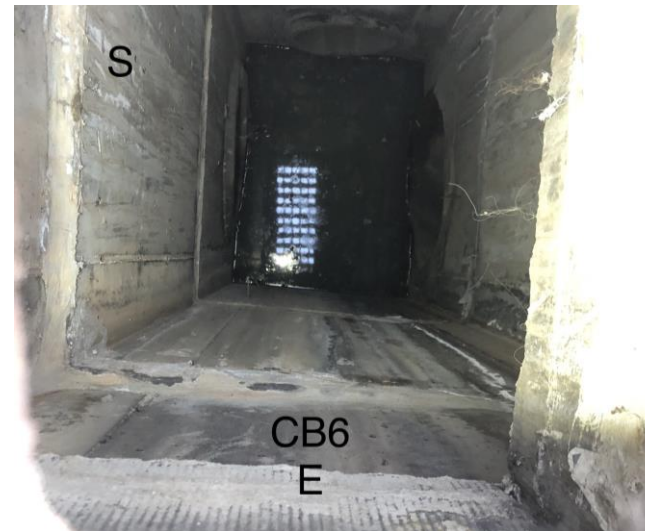
Photograph #6 – View of the south and east wall of CB6 with grout applied to joints.

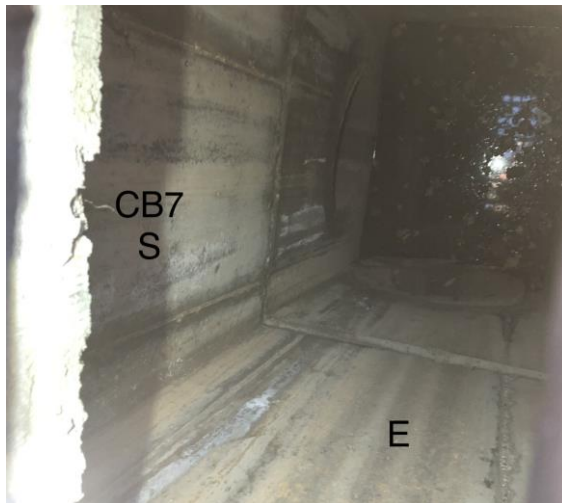
Photograph #7 – View of the south and east wall of CB7 with grout applied to vertical cracks.

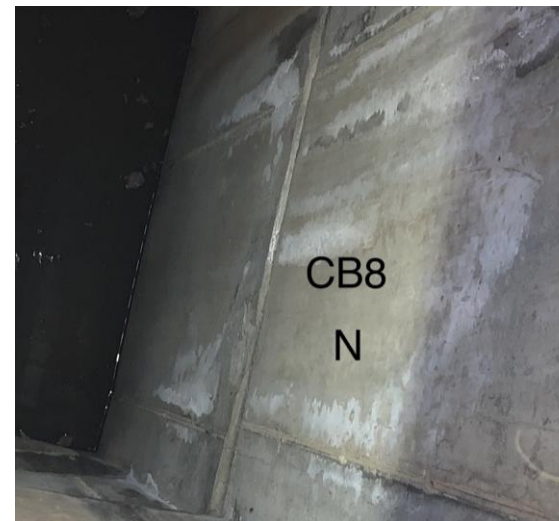
Photograph #8 – View of the north wall of CB8 with grout applied to vertical cracks.

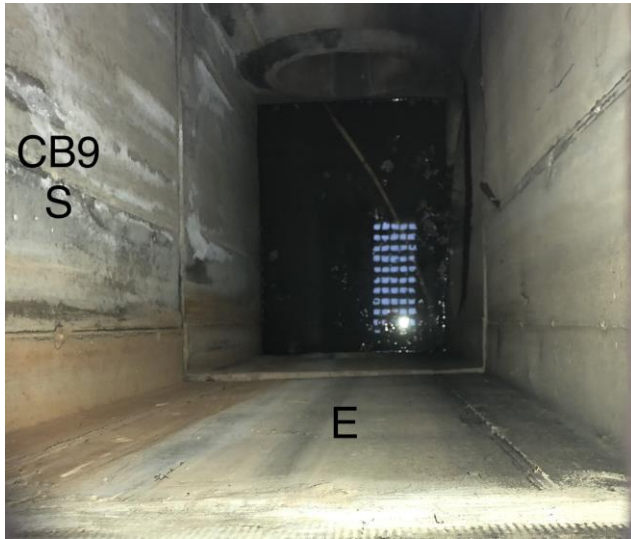
Photograph #9 – View of the south and east walls of CB9.

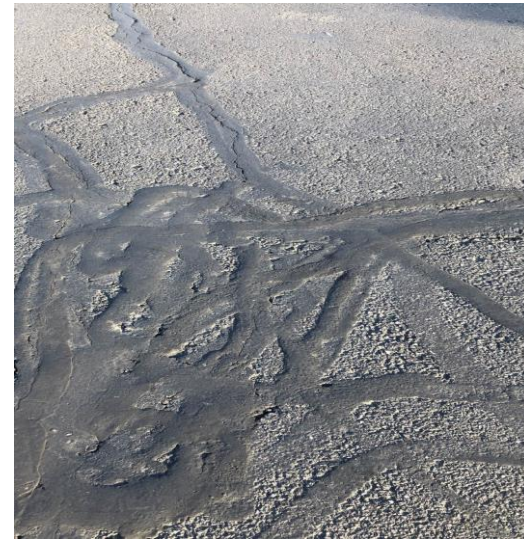
Photograph #10 – View of asphalt cracks filled with tar sealant.

Kleinfelder personnel observed tar sealant had been placed since the May 2022 inspection, primarily in the asphalt near the gas station and through traffic areas

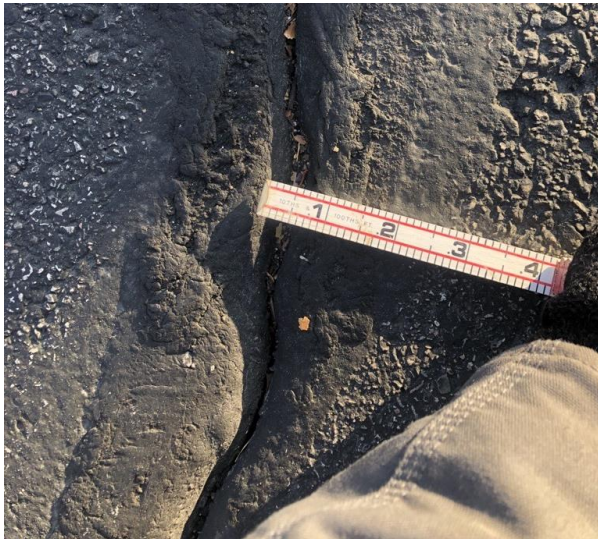
During the November inspection, asphalt barriers had minor damage due to shallow cracks indicative of normal wear, some of which had been sealed with tar. Some cracks were observed in the tar seals. Several areas of asphalt damage were observed in the northern and southern asphalt parking lot areas where asphalt adjoins concrete drainage features. The cracks depicted on Figure 1 ranged from ¼ inch to 1 ½ inches in depth and ½ inch to 1 inch across. The cracks indicated on Figure 1 were not observed to have breached the asphalt barrier and exposed soil that would present an exposure risk to potential receptors and are typical in asphalt pavements given Utah's climate and the related freeze and thaw cycles. The asphalt is monitored regularly and repaired annually, or more frequently if significant damage is observed. If Kleinfelder or Costco observes significant damage that could potentially expose receptors to underlying soil such as a pothole, those locations will be recorded and repaired as they are discovered.

Photograph #11 – Example of cracks observed in asphalt.

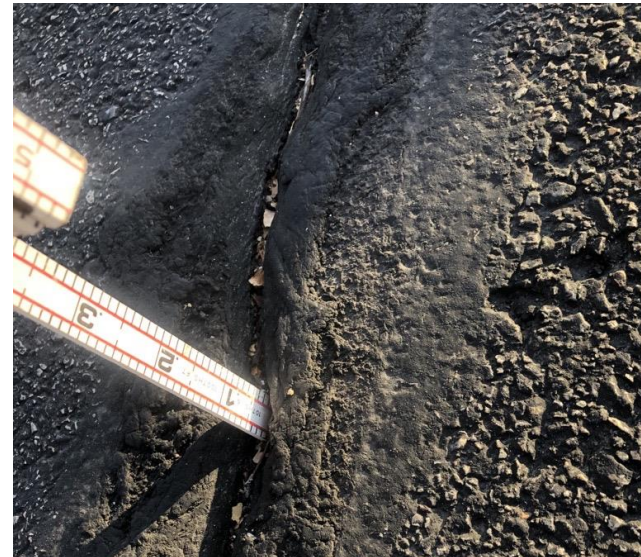
Photograph #12 - Example of cracks observed in asphalt.
